ARBORICULTURAL IMPACT ASSESSMENT REPORT

PROPOSED CYCLEWAY

NEW SOUTH HEAD ROAD, ROSE BAY

March 2019

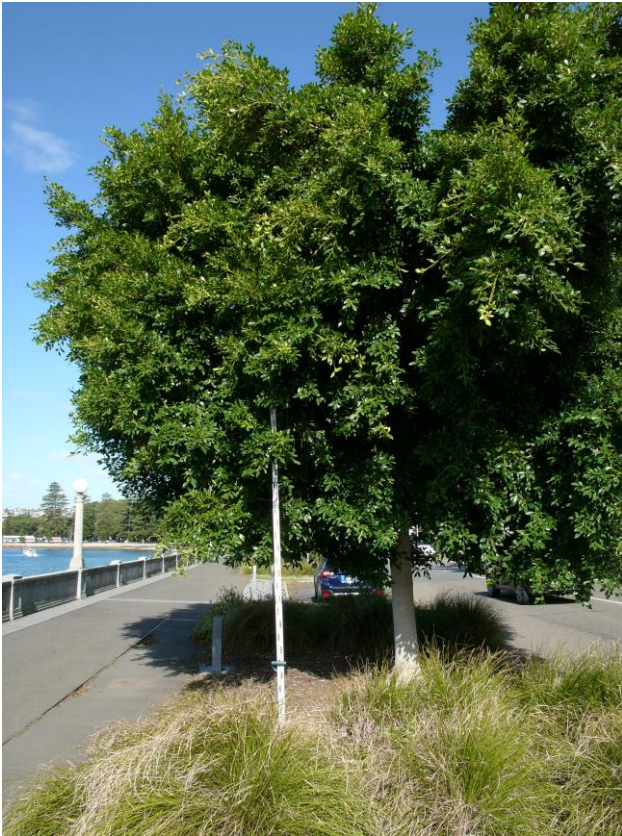
Plate 9 – T10

| Tree Identification No. | Species | Height (m) | Spread (m) | Trunk Diameter (mm) | Live Crown Size (m ²) | Maturity Class | Condition | Previous Pruning | Health | | Remaining Safe Useful Life Expectancy (SULE) | Landscape Significance Rating | Retention Value | Location |
|---|---|---|---|---|---|---|--|--|---|---|--|---|---|---|
| 10 | <i>Ficus microcarpa</i> var. <i>hillii</i> (Hill's Weeping Fig) | 6 | 7 | 239 | 35 | I | Appears stable with sound branching structure. Exhibits a small wound at three metres due branch loss (storm damage) - main leader. | No Evidence | Very Good | Low foliar insect infestation (Thrips) + sooty mould | Long - more than 40 years | 5 | Moderate | Road reserve |

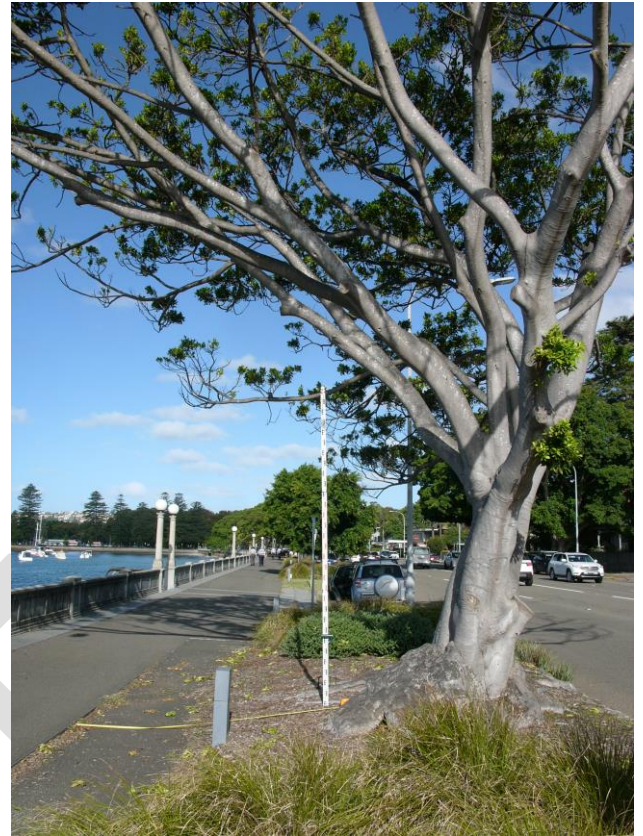
Plate 10 – T11

| Tree Identification No. | Species | Height (m) | Spread (m) | Trunk Diameter (mm) | Live Crown Size (m ²) | Maturity Class | Condition | Previous Pruning | Health | | Remaining Safe Useful Life Expectancy (SULE) | Landscape Significance Rating | Retention Value | Location |
|---|---|---|---|---|---|---|--|--|---|---|--|---|---|---|
| 11 | <i>Ficus microcarpa</i> var. <i>hillii</i> (Hill's Weeping Fig) | 9 | 18 | 863 | 108 | M | Appears stable with poor branching structure. Exhibits a severe bark inclusion at GL to 1 metre. Large buttress and burl at base. Large axial wound on trunk at 0.5 to 2 metres with decay evident. Substantial crown dieback with 50% deadwood. | Previously lopped at 3 metres (crown restored). Crown lifted to 4 metres. | Fair with thinning crown | Moderate foliar insect infestation (Thrips) + sooty mould | Short 5-15 Years | 1 | High | Road reserve |

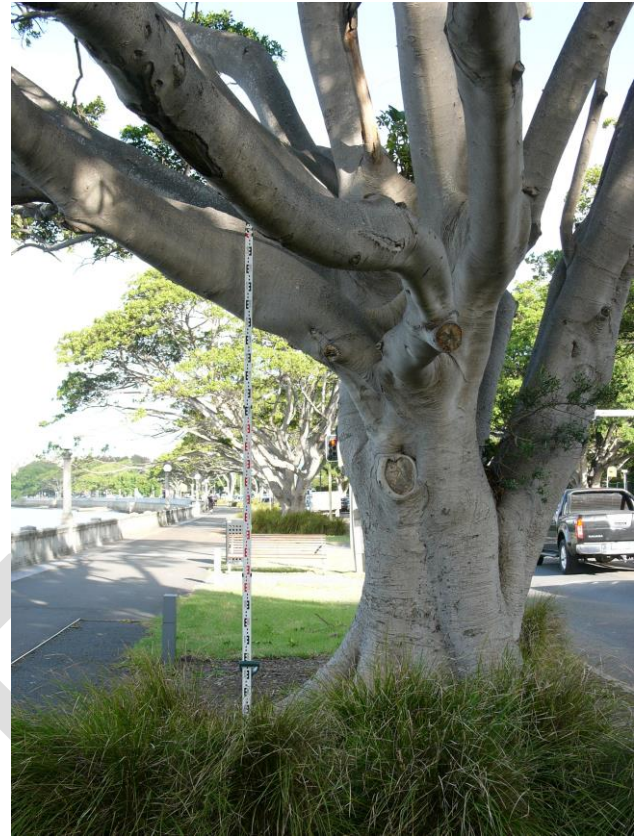
Plate 18 – T19

- 4.4.4 A few of the trees toward the western end of the Promenade [T19, T20 & T21] exhibit evidence of pathogenic fungal infections, affecting the lower trunk, butt and root crown area. Such disease creates significant structural weakness, which can lead to wholesale tree failure. The disease appears to be a *Phellinus species* (Bracket Fungus). This disease has led to many failures of similar size and age trees in Hyde Park and warrants further investigation and diagnostic testing (beyond the scope of this report).

| Tree Identification No. | Species | Height (m) | Spread (m) | Trunk Diameter (mm) | Live Crown Size (m ²) | Maturity Class | Condition | Previous Pruning | Health | | Remaining Safe Useful Life Expectancy (SULE) | Landscape Significance Rating | Retention Value | Location |
|---|---|---|---|---|---|---|--|--|---|---|--|---|---|---|
| 19 | <i>Ficus microcarpa</i> var. <i>hillii</i> (Hill's Weeping Fig) | 16 | 24 | 1076 | 288 | M | Stability suspect with fair branching structure. Exhibits multiple high bark inclusions at 1.5 metres at junctions of PLs. Exhibits a moderate wound to the lower trunk/butress (dieback to vascular tissue) with decay evident. 20% deadwood. | Previously lopped at 4-5 metres (crown restored). Crown lifted to 5 metres. Deadwooded | Fair with thinning crown | Moderate foliar insect infestation (Thrips) + sooty mould. Pathogenic fungal infection (butt Rot/Root Rot disease). Large fruiting bodies (possibly <i>Phellinus</i> sp.) at GL | Transient (less than 5 years) | 1 | Moderate | Road reserve |
