# **PROPOSED SHARED PATHWAY NEW SOUTH HEAD ROAD DOUBLE BAY TO ROSE BAY**

## **HISTORICAL ARCHAEOLOGY IMPACT ASSESSMENT**

**APRIL 2019**

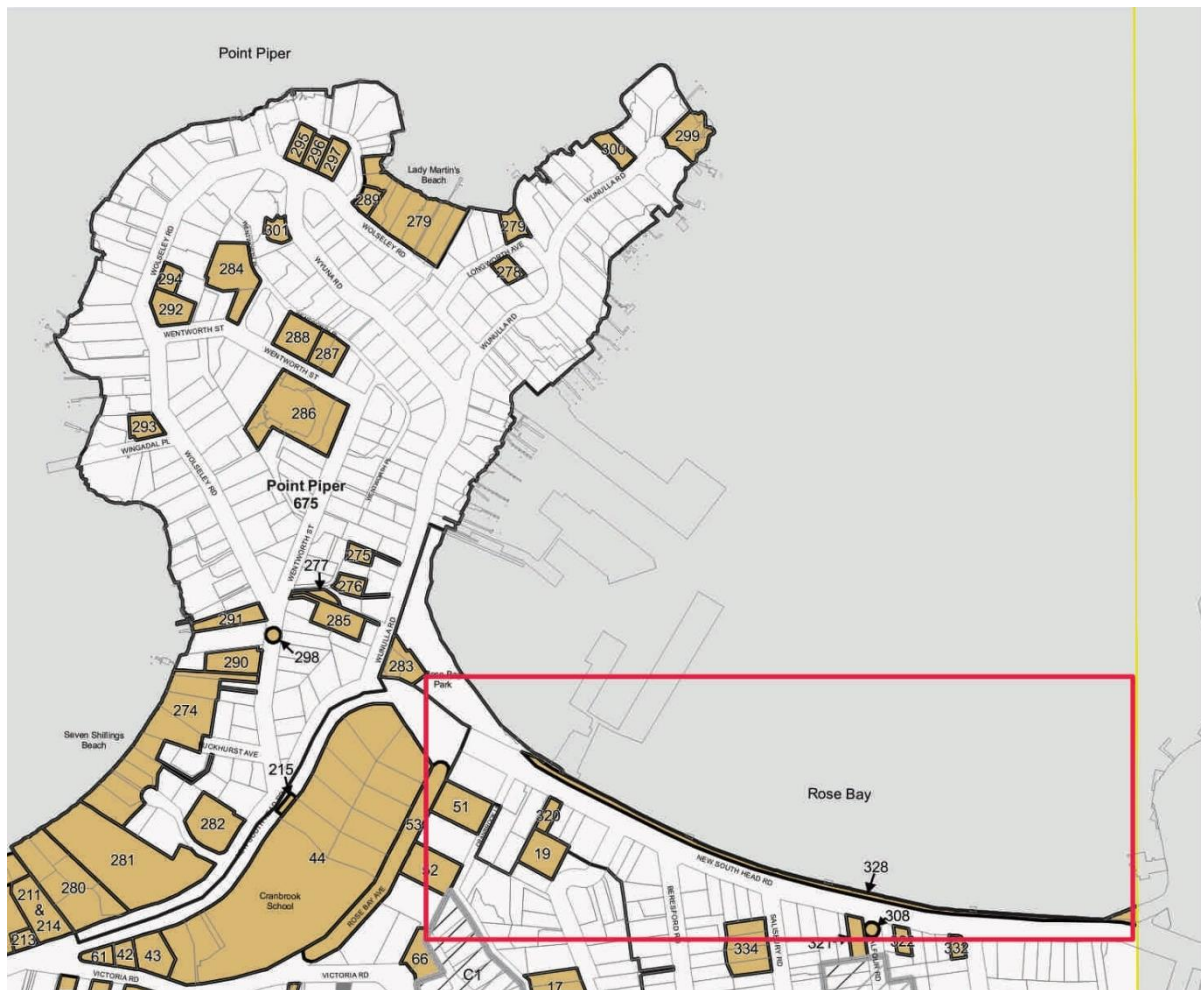
Figure 1.3: Detail of 'Heritage Map - Sheet HER\_002' Woollahra LEP 2014, showing the boundaries of the Rose Bay seawall, balustrade and promenade (LEP 328). The approximate study area is marked in red.

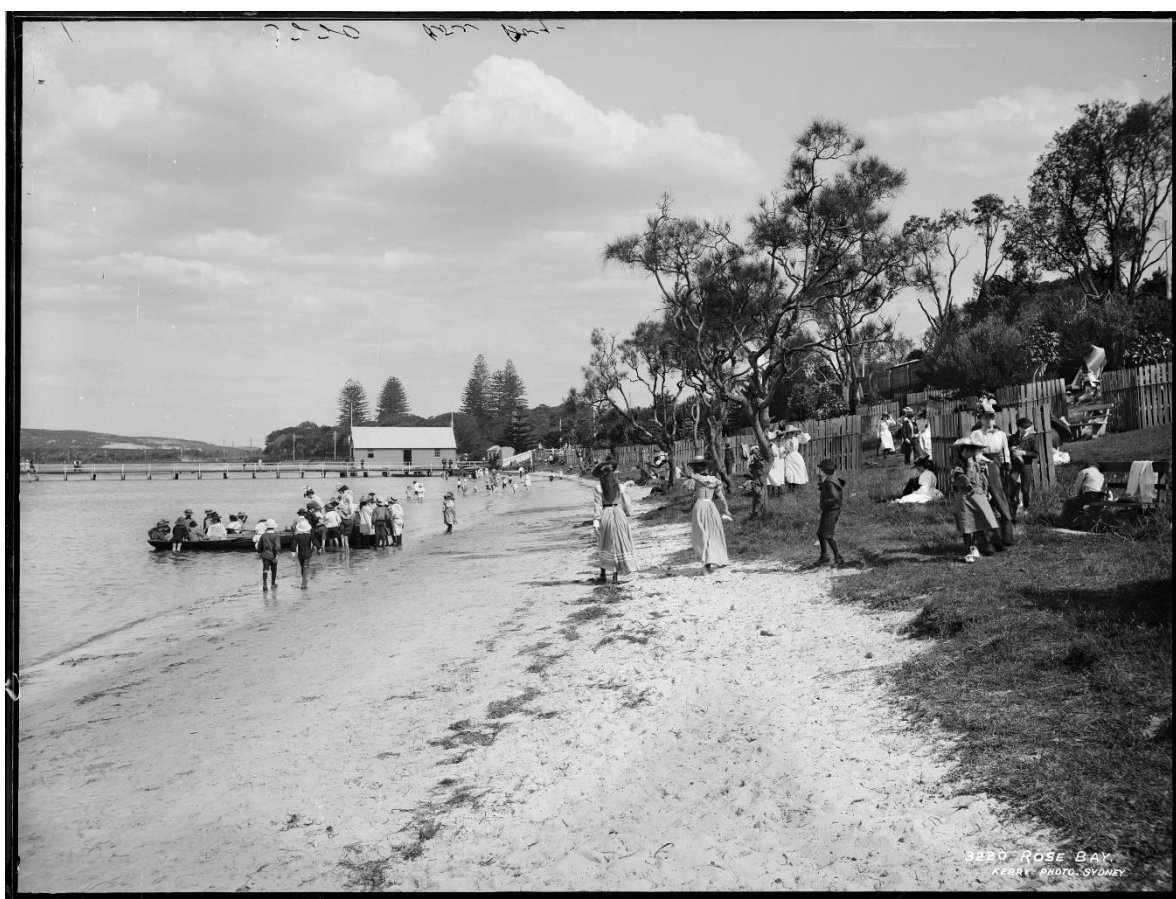
Figure 2.4: View of the Rose Bay beach, c.1887-1917, prior to the reclamation of land and construction of the seawall. Glass plate negative, Kerry and Co. Courtesy of MAAS.

Photographs of Rose Bay from the late 19th/early 20th centuries show a public pier with a boat shed and jetty to the east of Rose Bay beach (Figure 2.4). Although the beach was popular with day trippers, the harbour was apparently spoiled by a ‘...stretch of evil-smelling decomposed matter that is assuredly not seaweed’,<sup>6</sup> possibly on account of the HMAS Tingira moored in Rose Bay, although more likely decomposed seaweed.<sup>7</sup> Prior to the construction of the seawall, the sea:

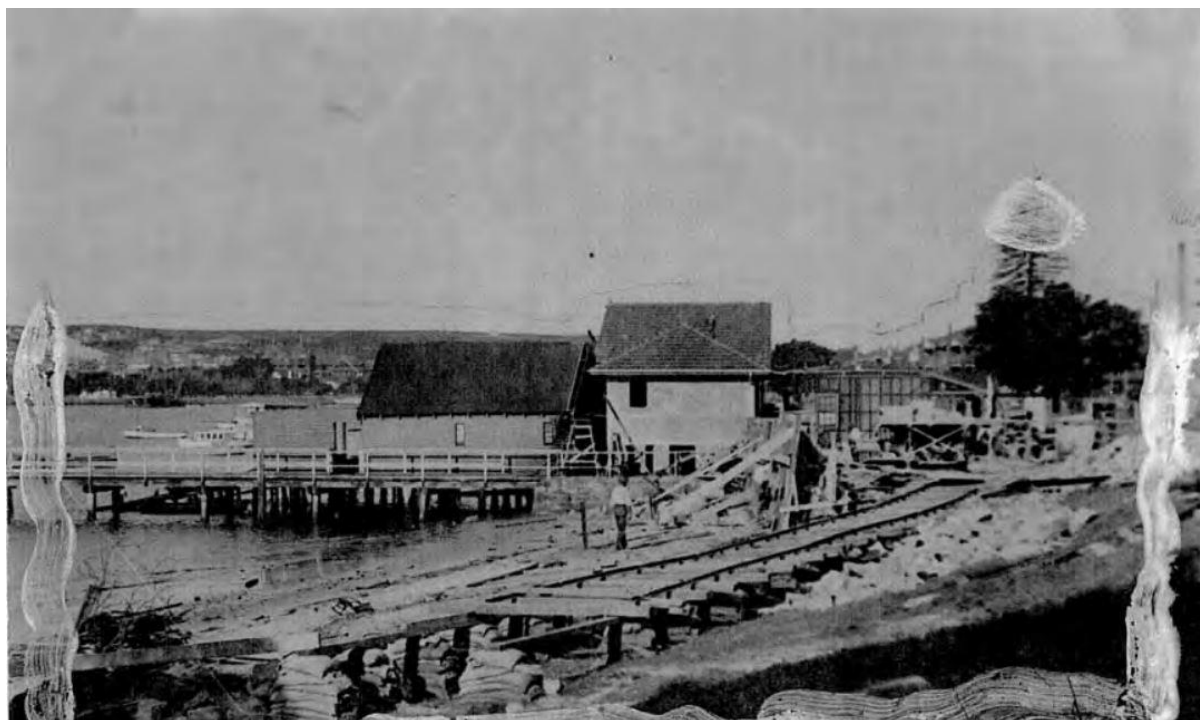
Construction on the concrete seawall began in 1924 (Figure 2.5), and the Rose Bay Esplanade was officially opened on the 19th February 1926. Land was reclaimed to a depth of 50ft (15m) for half a mile (800m), and a concrete parapet was erected overlying the seawall. The reclamation allowed the widening of New South Head Road to 105ft (32m).<sup>12</sup> Sewerage drains were installed to carry waste from the former swamp area under New South Head Road and through the seawall into the sea.

Figure 2.5: The Rose Bay seawall and footpath during construction, c. 1926. Courtesy Mitchell Library, SLNSW Small Pictures File PXA 2136/Box 2 No. 15.

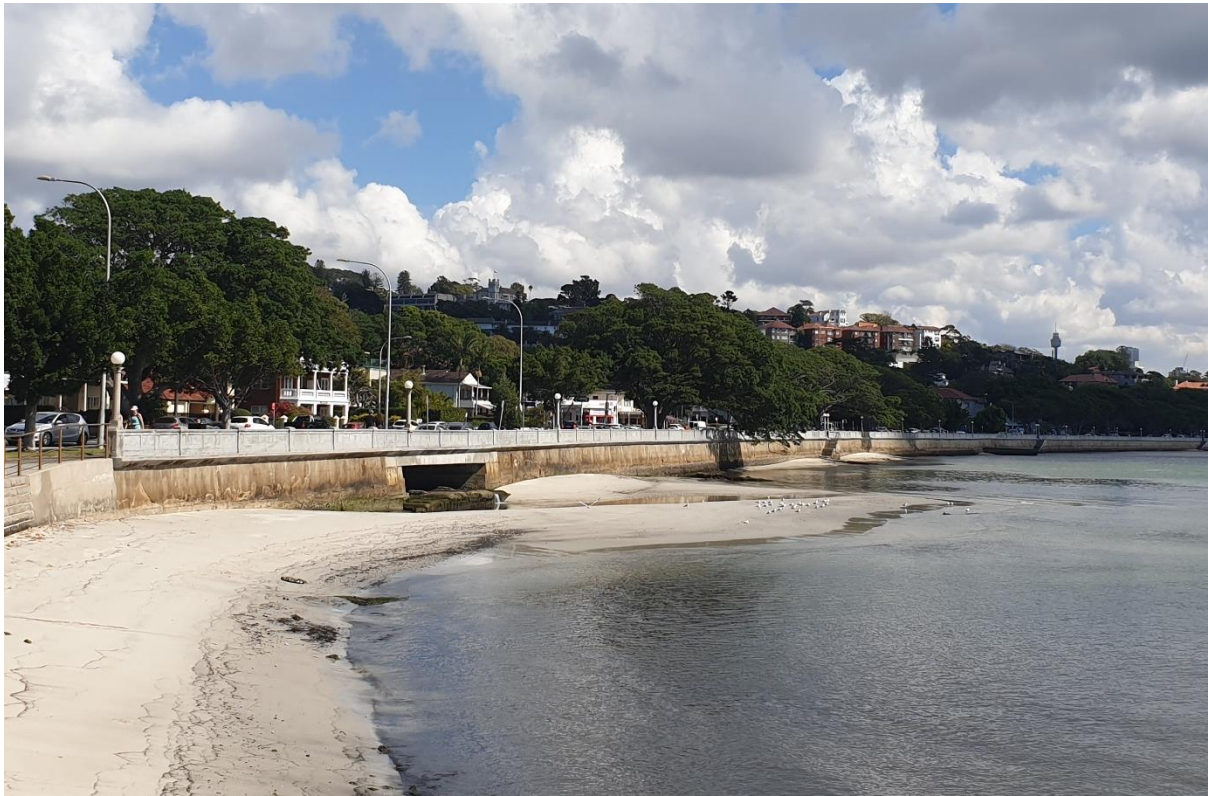
Figure 3.1: Detail of the eastern extent of the seawall, showing a stormwater outlet. View to southwest. Casey & Lowe 2019.

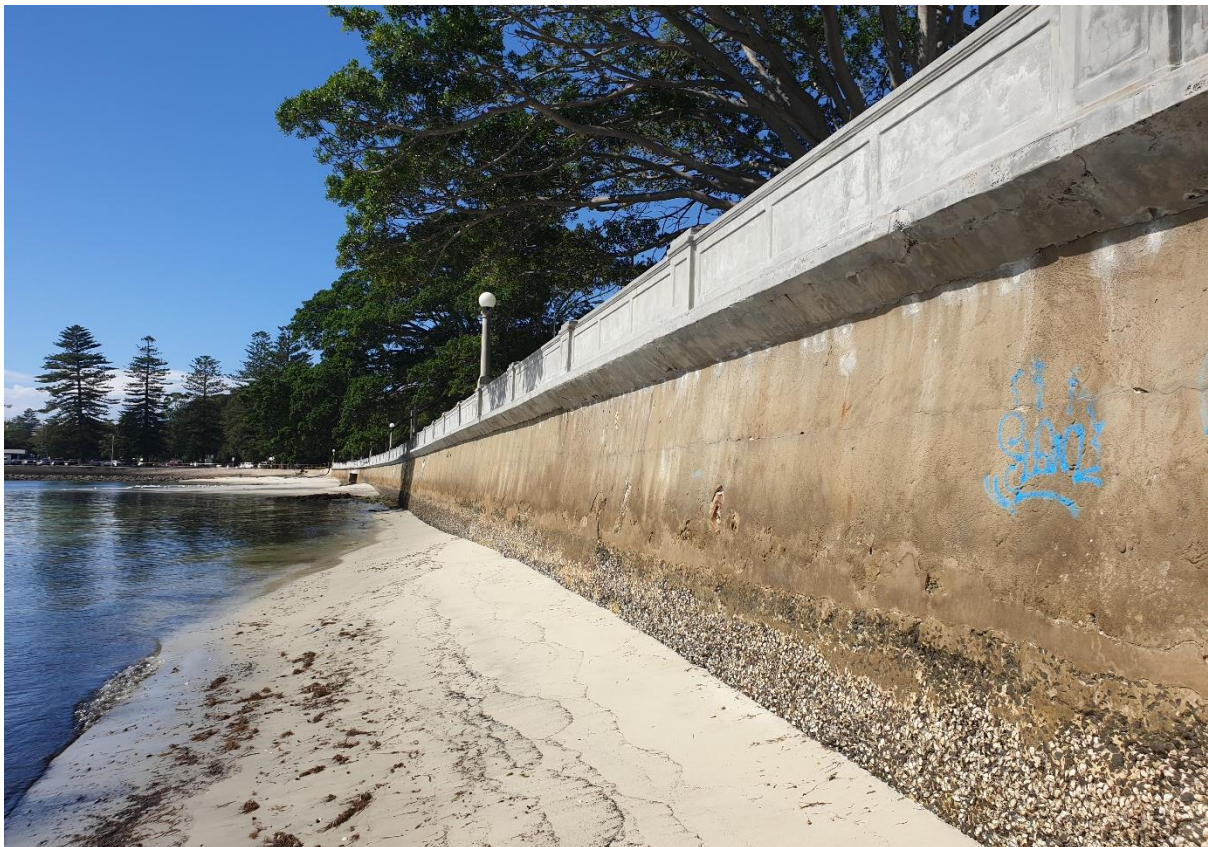
Dr Kat McRae, Casey & Lowe, inspected the study area on 15 April 2019. Much of the original concrete seawall is retained in its existing condition (Figure 3.1, Figure 3.2), however significant restoration and upgrade works to the balustrade, light standards (Figure 3.3) and stairs (Figure 3.4) were carried out in 2007. The footpath was also reconstructed to its original 4m width (Figure 3.5) during this restoration program. The original surface is not known. The avenue of fig trees (Hill's Weeping Fig) likely dates to the original construction of the seawall and expansion of New South Head Road in the 1920s, although a significant replanting program, specifically of native groundcover, was undertaken during the 2007 restoration works.

Figure 3.2: Detail of the seawall, which largely appears to be in its existing condition. View to east. Casey & Lowe 2019.

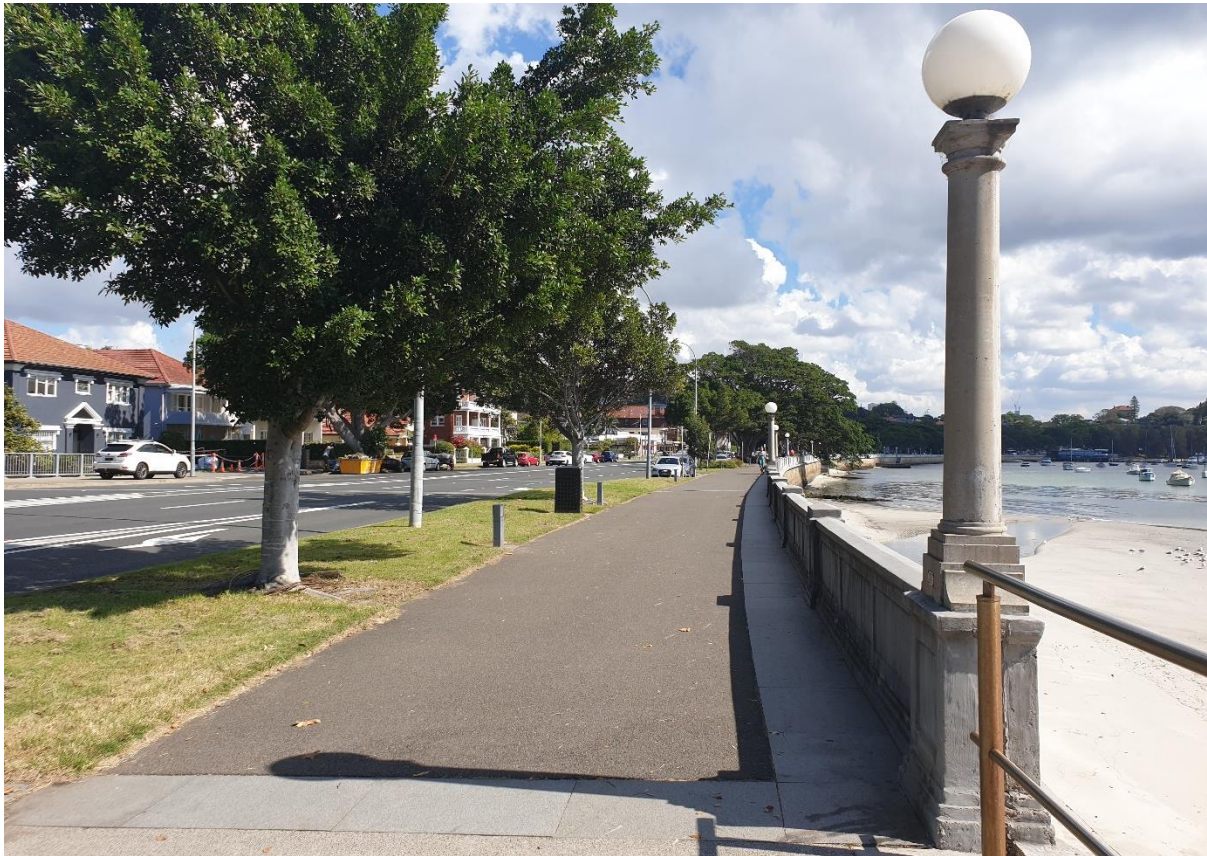
Figure 3.3: View to west along the promenade. Note the balustrade has undergone significant repairs and the original lamp standards were replaced in 2007 with exact replicas. Casey & Lowe 2019.

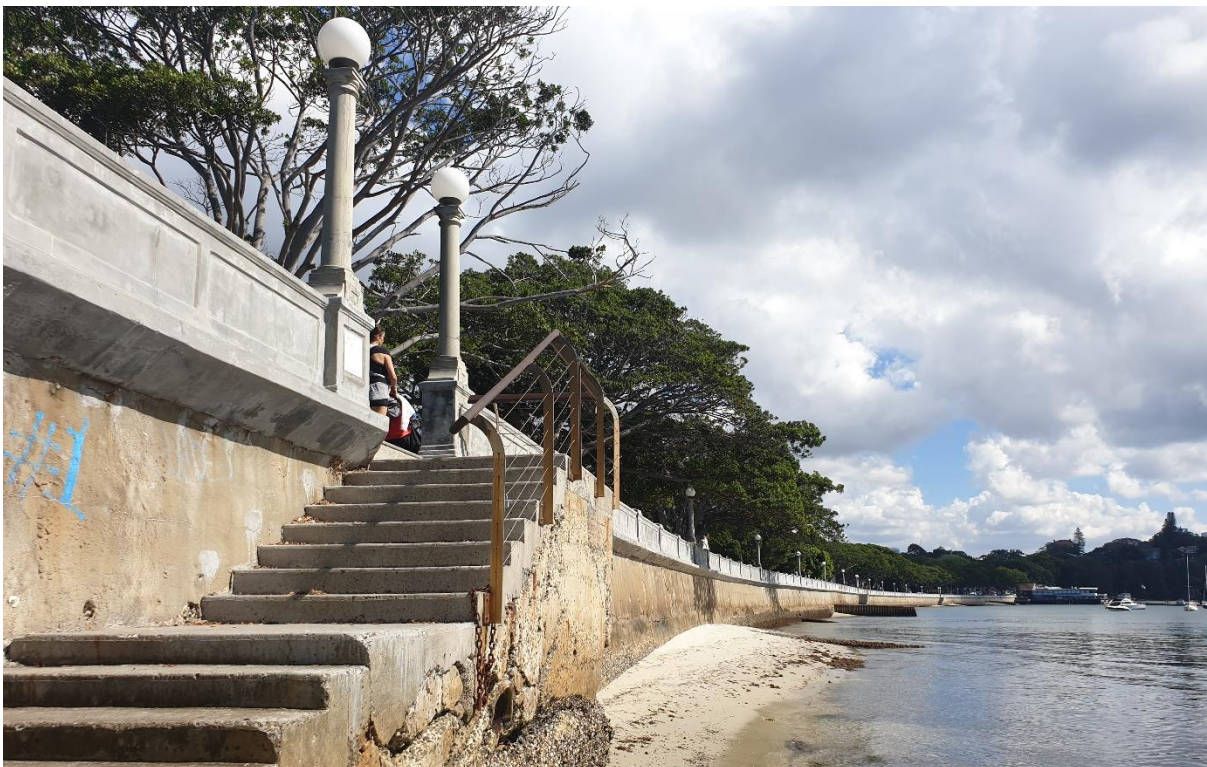
Figure 3.4: One of three sets of stairs along the seawall providing access to the bay. New stairs were rebuilt on top of the existing stairs in 2007. View to west. Casey & Lowe 2019.

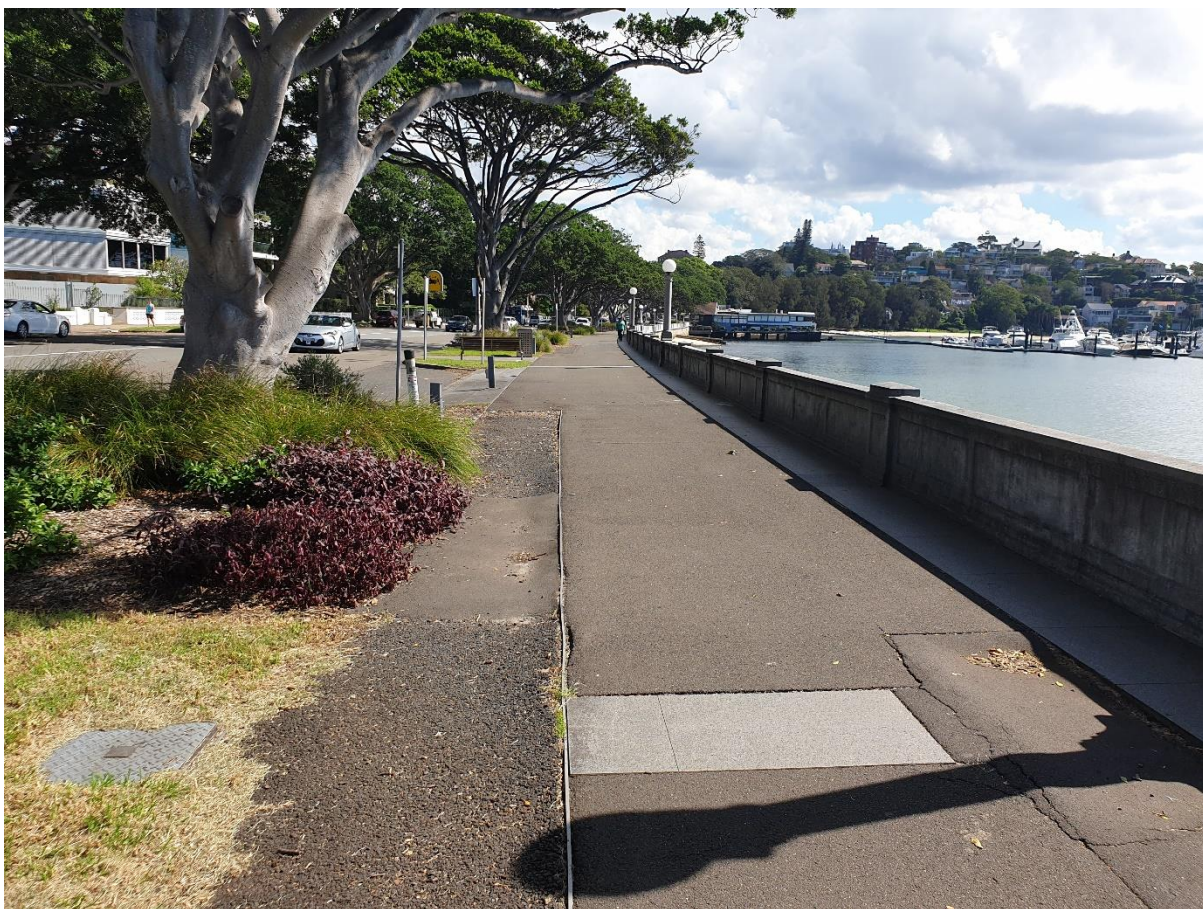
Figure 3.5: View along the promenade, showing the footpath and landscaped verge and parking bays to the north of New South Head Road. The footpath was largely reconstructed in 2007. View to west. Casey & Lowe 2019.
