**RE : DRAFT Due Diligence Aboriginal Heritage Assessment
Gap Park Tramway Path, Watsons Bay**

1 What we are assessing

The property and proposal

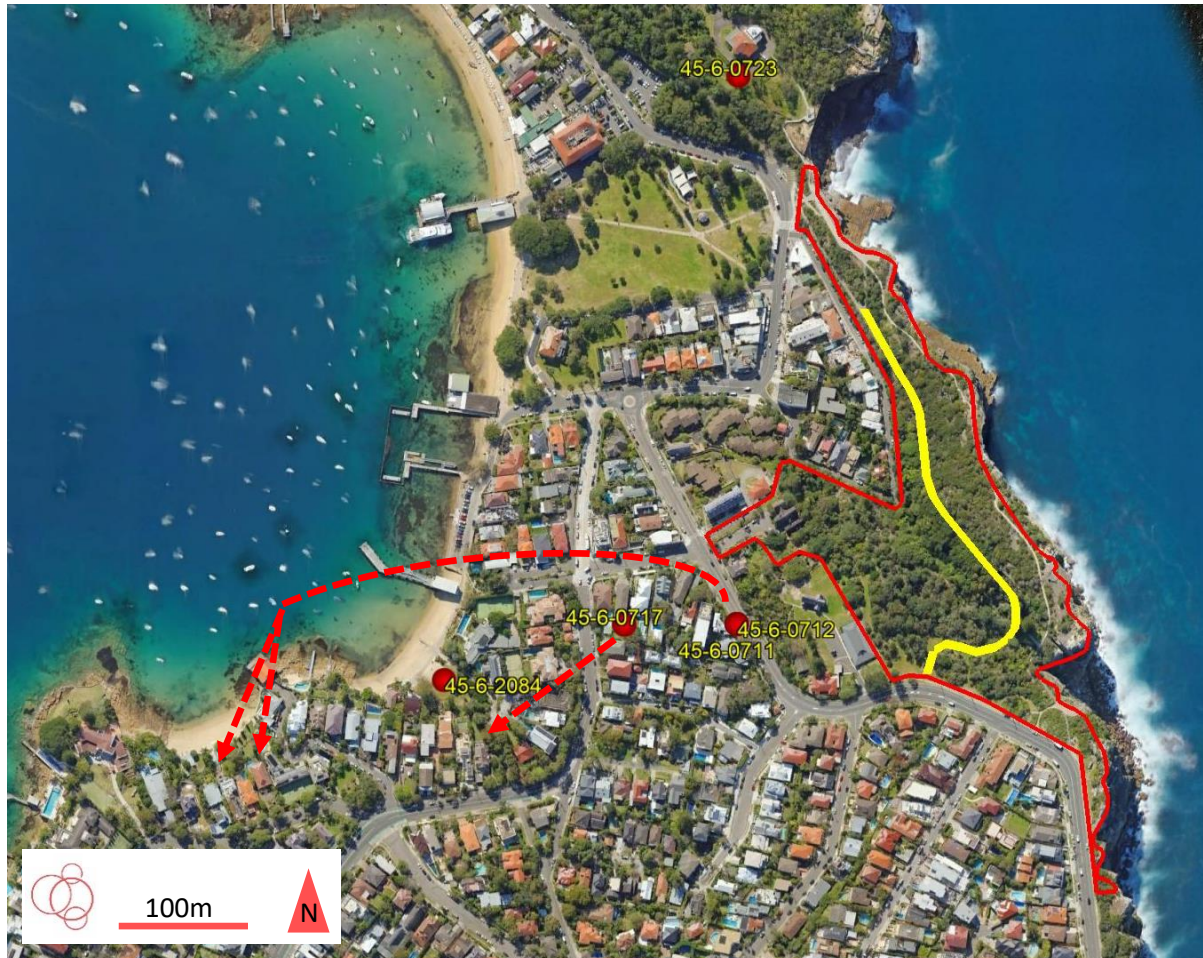
Only five of the 67 sites are located within 500m of the study area (**Figure 5**), however some of these have been incorrectly registered. Rock engraving sites #45-6-0711, #45-6-0712 and #45-6-0717 were recorded in the 1890s by surveyor W.D. Campbell as part of a study he conducted on rock engravings in the Sydney area.¹⁴ The original detailed plans and sketches made by Campbell are held in the NSW State Library and contain more specific information about site locations.¹⁵ Between these maps and Campbell's published descriptions, it is clear that these three engravings are located several hundred metres further west, in association with areas behind Gibson Beach (where

rockshelter #45-6-2084) is located. The final of the five registered sites shown in **Figure 5** is an engraving located within the national park, about 200m to the north of northern end of the current study area.

Figure 5. Registered Aboriginal sites close to the study area with approximate corrected locations indicated with red arrows.

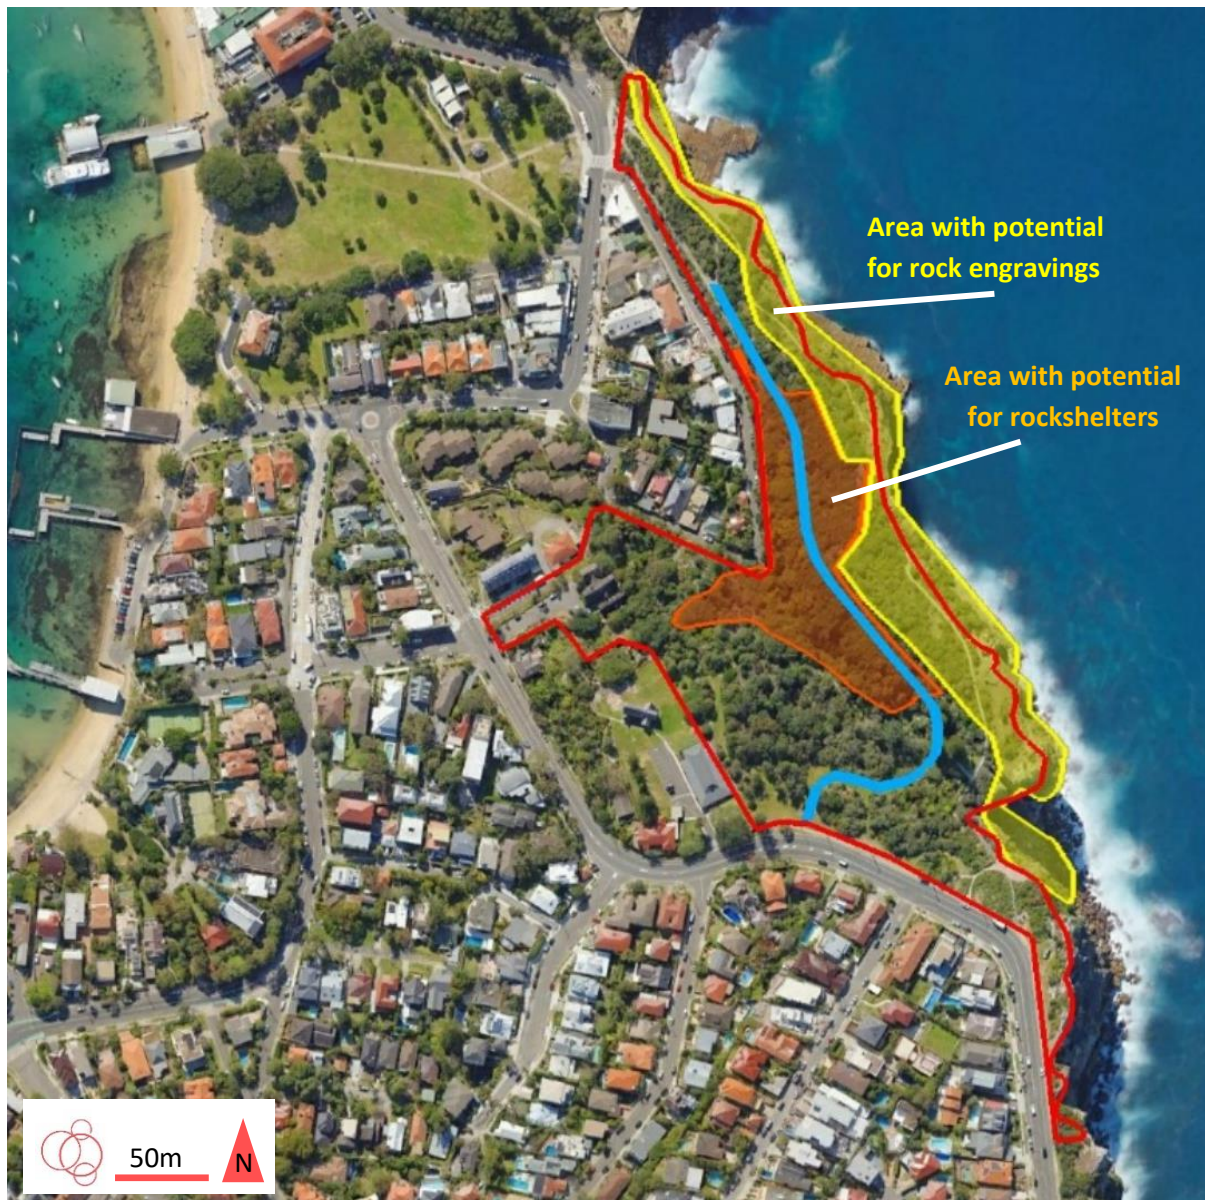
Gap Park was the subject of a preliminary Aboriginal archaeological study in 2007 to inform future planning for the park.¹⁶ The study included background archaeological and historical research and a brief field inspection. The inspection did not locate any Aboriginal sites, but observations from this and background materials, allowed the identification of areas of potential archaeological sensitivity, as shown in **Figure 6**. These included an area associated with outcropping sandstone along the ocean coast which could potentially contain rock engravings or axe grinding grooves on their exposed upper surface. The other is an area west of this and covering some of the current study area, in which there is considered to be some potential for rockshelters with archaeological evidence to be present.

Figure 6. Approximate extent of areas of potential archaeological sensitivity as determined in the AHMS 2007 study, in relation to the current study area (blue line).

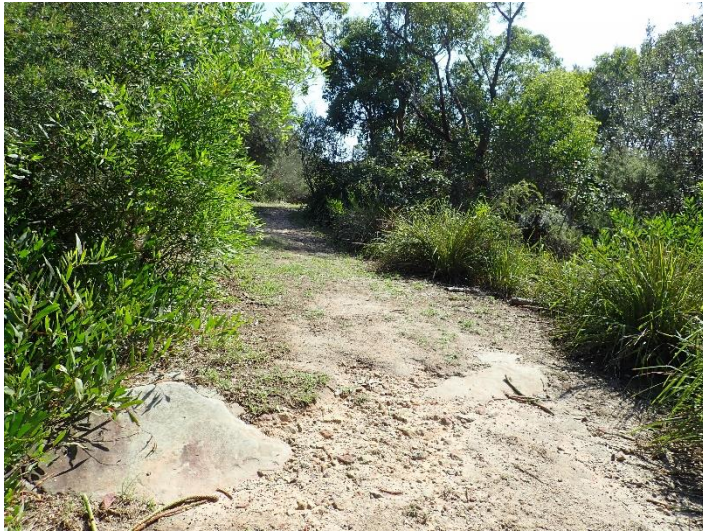
The southern 70m of the walk from Old South Head Road traverses an area filled in the 1970s and currently cleared and grassed (**Figure 7**). The next 60-70m includes grassed areas and existing tracks but includes a roughly 10m section through regrowth bush at its northern end, before meeting the original alignment of the tramway (**Figure 8**). This is also where the path meets the western edge of a sandstone outcrop, at the base of which is a low (ca. 0.5m high) overhang. Immediately to the north of this is a small shelter about 1m high and 1.5m deep and 3m long, with a brick pylon at its entrance, probably erected in association with the adjacent tramline (**Figure 9**). The floor deposit is partly disturbed loose grey sand. No artefacts, faunal remains or charcoal were observed, nor was any art observed on the roof or rear wall. The overhang is small and unlikely to have been used by Aboriginal people in the past, however this cannot be definitely discounted.

Figure 7. View west over filled area at the southern end of the proposed path.

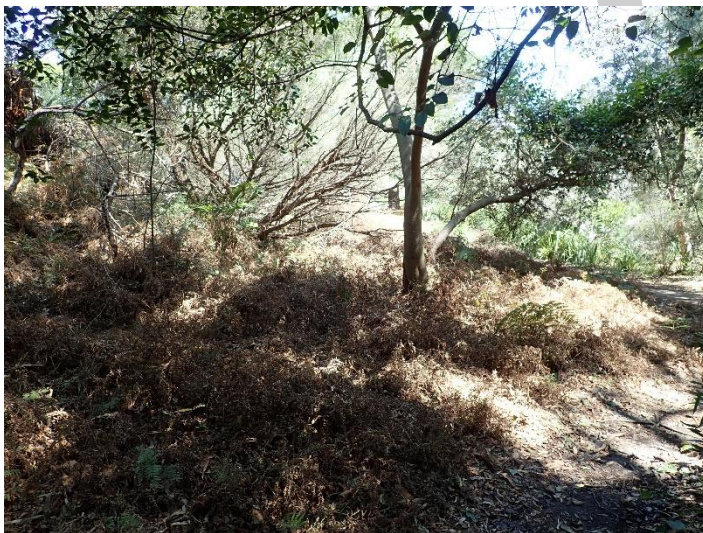
Figure 8. View south from low rockshelter to area where new path required to be cut through existing bush.

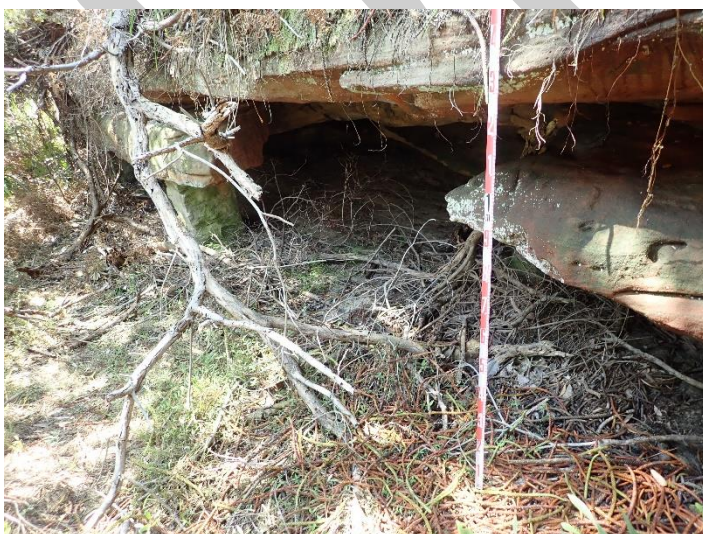
Figure 9. View north-east into small rockshelter with supporting brick pylon at its entrance (10cm gradations on scale).

4. The location of the small shelter as shown in **Figure 13** should be protected through the erection of temporary protective fencing during construction to prevent people or dust from entering the shelter.

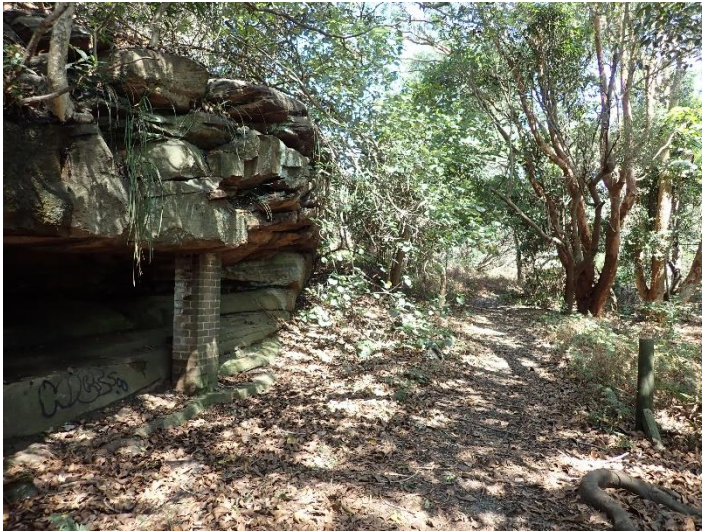
The next 100m of the route follows an existing path along the original tramline alignment. The path is strewn in sections with broken bitumen from a previous attempt to create a hard surface along the track. Some of this is loose and could easily be removed without damaging the soil below, but other pieces appear stuck to the underlying deposit. The tramline appears to have been constructed by cutting through the steeply sloping edge of the sandstone outcrop to the east and using the spoil to level a 2-3m wide corridor above the continuing moderate to steep slope below (west) (**Figure 10**). Mature fig trees are growing in this slope immediately west of the path.

Figure 10. View south along former tramline showing cut sandstone outcrop to the east (left) , levelled tramline corridor and continuing slope to the west (right).

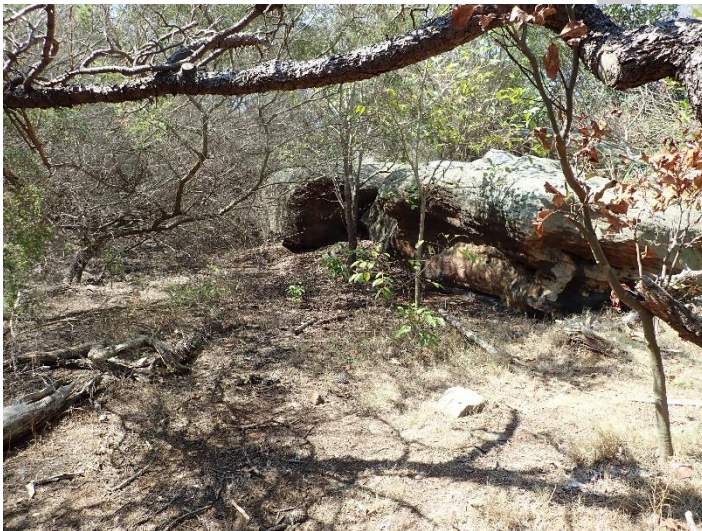
Figure 11. Sandstone outcrop on eastern edge of interpretation/seating area and ground below which consists of shallow vegetation and soil over sandstone.

5. The design of the interpretation/seating area shown in **Figure 13** should seek to minimise subsurface impacts, as there is potential for rock engravings to be located immediately under the current ground surface. This could be achieved by raking over the existing top matter and building on top of this, rather than excavating for footings.

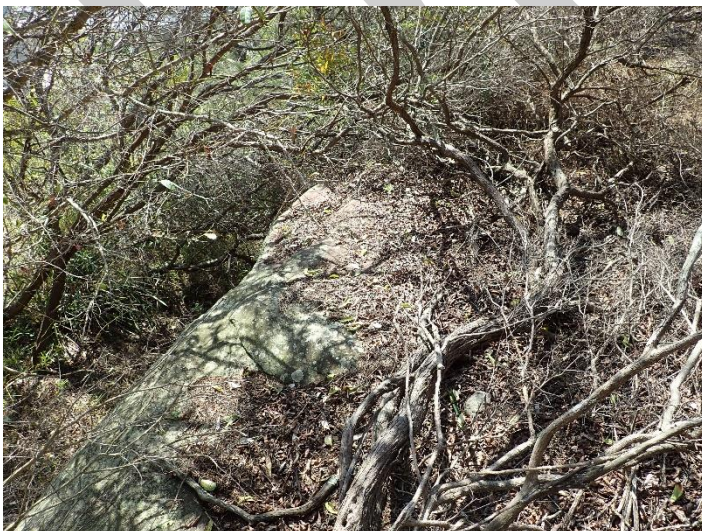
Figure 12. Sandstone outcrop immediately below the surface in the area proposed for interpretation and seating.
