Report on
Geotechnical Investigation

Proposed Mixed Use Development
136-148 New South Head Road, Edgecliff

Prepared for
Edgecliff Central Pty Ltd

Project 200333.01
March 2021

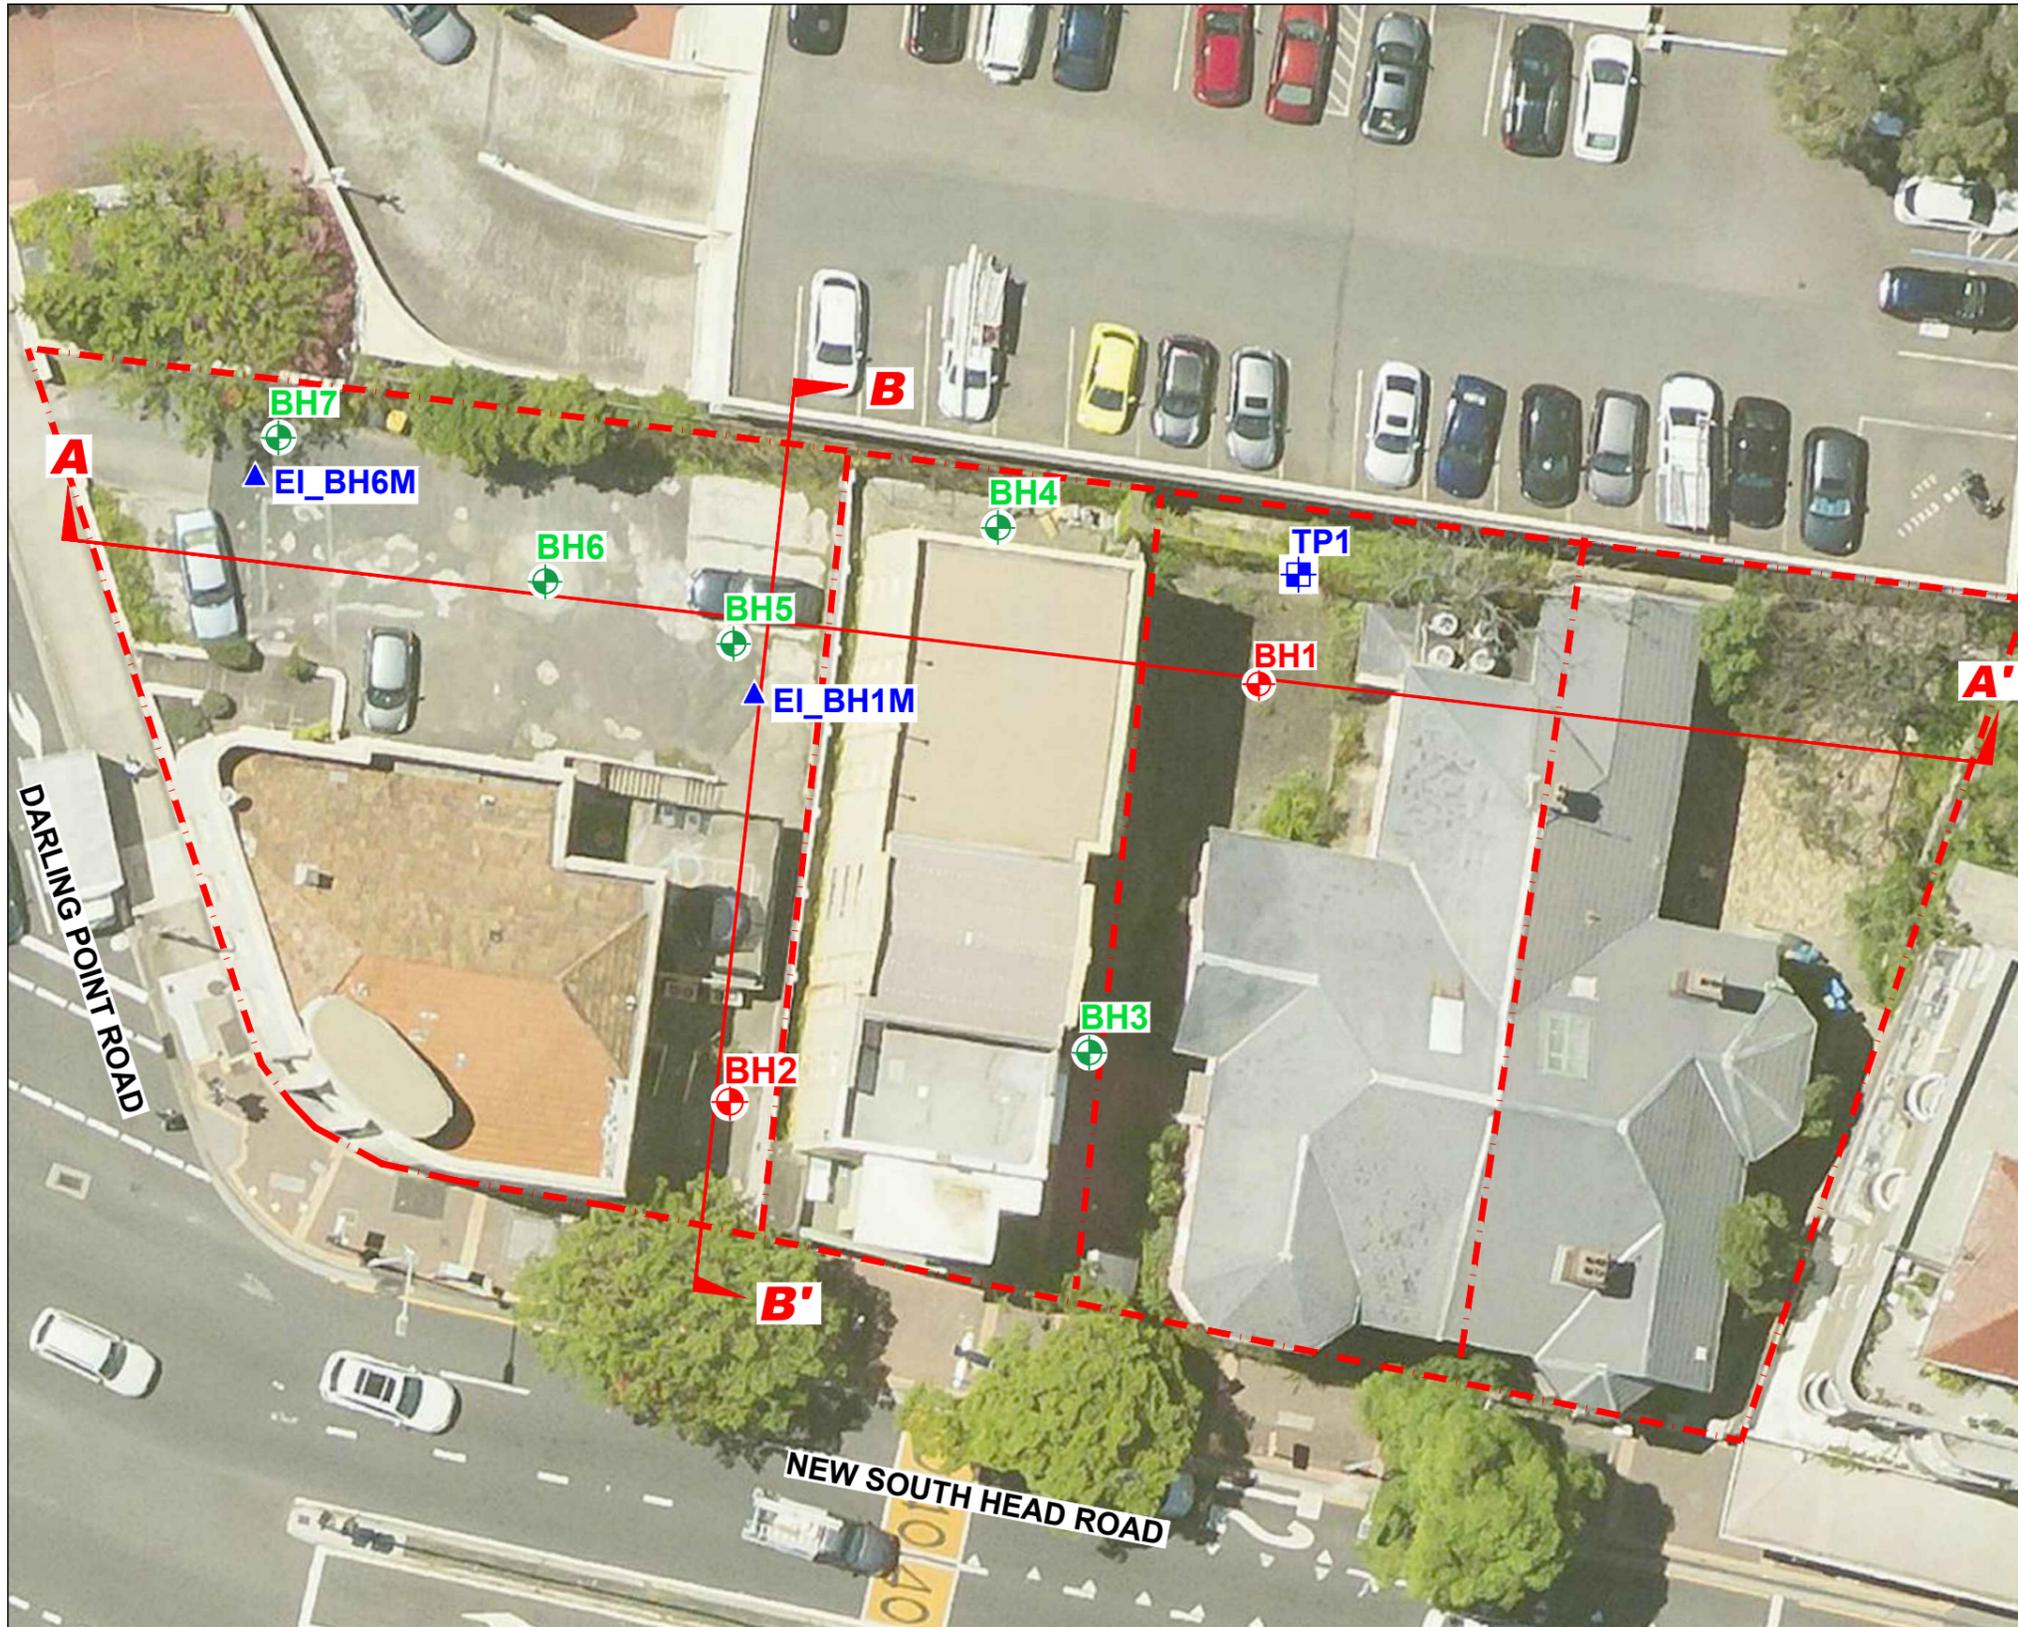
PROJECT No: 200333.01
 DRAWING No: 1
 REVISION: 0

All boreholes and test pits were backfilled with drilling/excavated spoil upon completion and were capped with concrete or asphalt. The test locations are shown in Drawing 1 in Appendix B. The boreholes locations were measured using a high precision GPS system accurate to 0.1 m in plan and elevation, with their details recorded on the borehole logs. It is noted that a further five shallow boreholes were drilled using a hand auger as part of DP's concurrent environmental assessment.

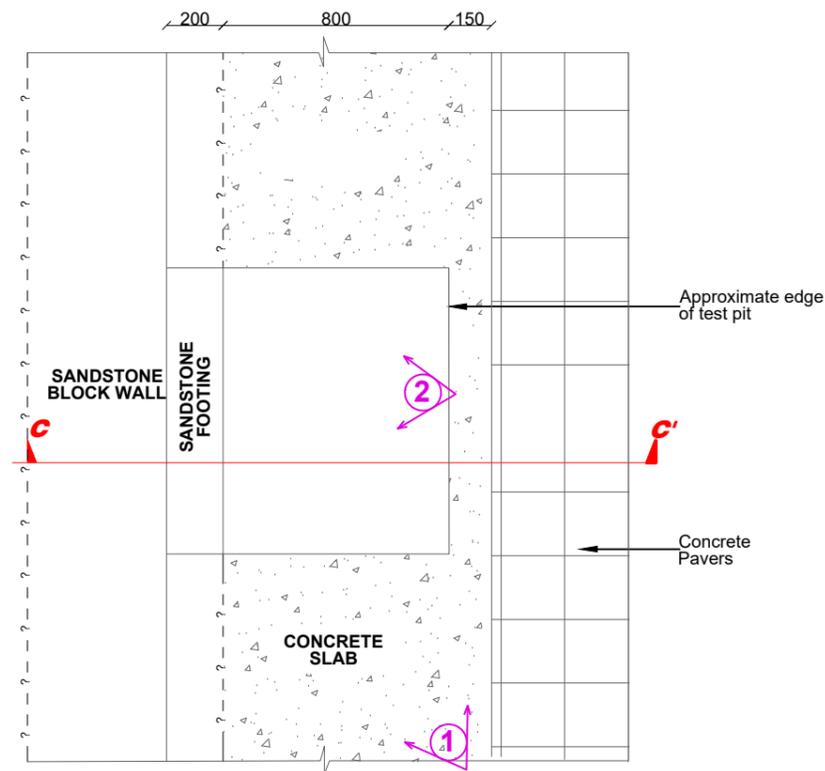
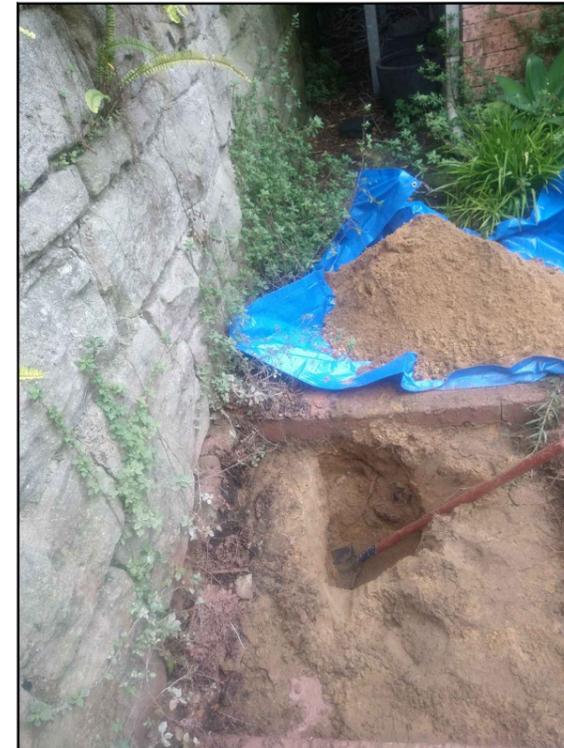
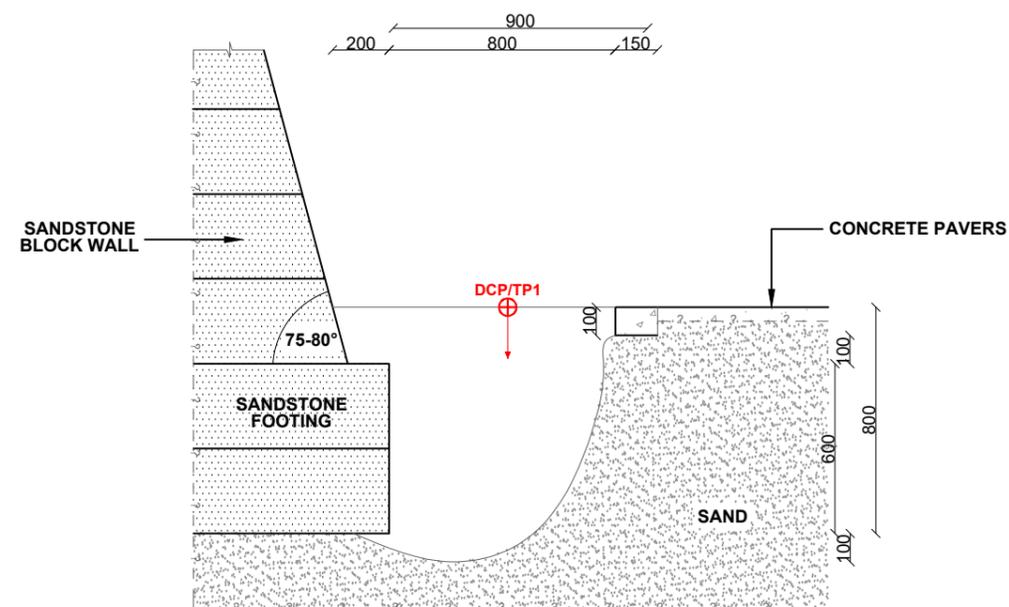
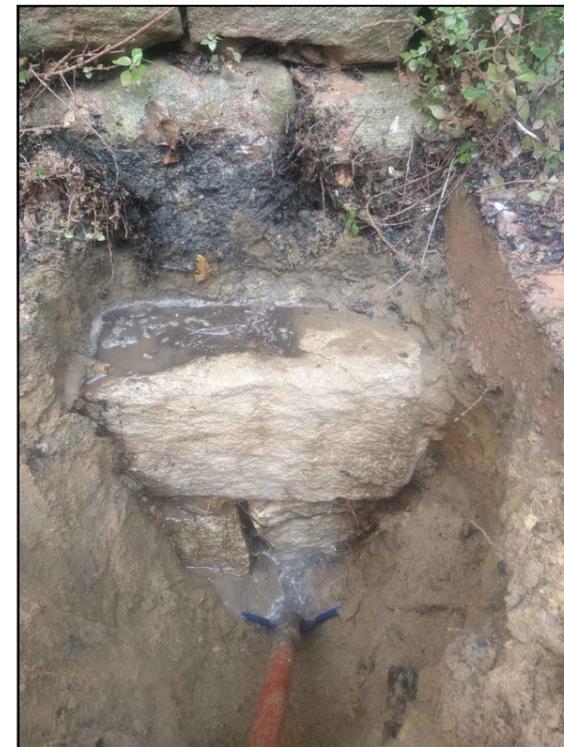
PROJECT No: 200333.01
 DRAWING No: 4
 REVISION: 0

The footing exposure test pit excavated adjacent to the existing heritage sandstone block wall noted the following conditions. Reference should be made to the footing exposure drawing (Drawing 4) provided in Appendix B.

- The sandstone block wall is situated along the northern site boundary and is approximately 30 m long. It extends from the common boundary between the property of 138-140 and 142-146 New South Head Road, Edgecliff to the north east corner of the site. The wall comprises sandstone blocks with mortared joints. The wall is generally in a good condition, however vegetation was observed to be growing from the between the sandstone blocks where mortar has been eroded away.

- The wall is approximately 4.5 m to 5 m high, estimated at 1.6 m wide at the base and decreasing in width as the wall tapers up in height. The face of the wall is inclined at approximately 75 to 80 degrees from horizontal.
- From the test pit footing exposure, the wall is founded upon a strip footing at approximately 0.6 m depth, estimated to be 1.6 m in width and comprises further sandstone blocks on medium dense to dense sand, as determined by the DPT to a depth of 1.4 m below the underside of the footing.

TITLE: **Footing Exposure - Test Pit 1**
Proposed Mixed Use Development
136-148 New South Head Road, Edgecliff

Test Pit ID	Inferred Footing Type	Depth to Base of Footing (m)	Estimated Width of Footing (m)	Material Exposed Below the Base of Footing	Allowable Bearing Capacity of Existing Foundation (kPa)
TP1	Sandstone Block Strip Footing	0.6	1.6 [^]	Medium Dense Sand	250*

Note: [^] The footing was found to be 0.2 m wider on the south side of the wall. It has been estimated that the footing is also 0.2 m wider on the northern side and that the base of the wall is 1.2 m wide.

The footings exposed in the footing exposure test pit appeared to comprise a sandstone block footing founded on medium dense sand with dense sand at depth, which would typically be suitable for an allowable bearing capacity of 250 kPa. However, given that these footings will be adjacent to the shoring wall of the proposed basement, geotechnical input will be required to inform the detailed design of the shoring wall.

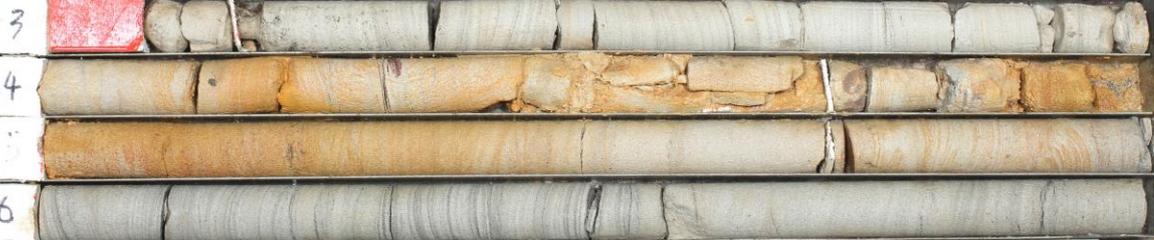
200333.01 - Edgecliff - BH1 - Start = 2.4m

2.40 - 7.00m

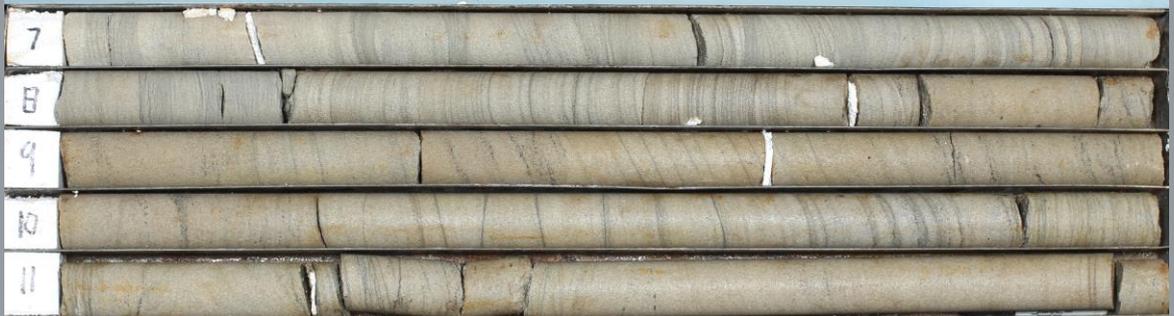
Project No: 200333-01
BH ID: BH1
Depth: 7.00 - 12.00m
Core Box No.: 2/4

7.00 - 12.00m

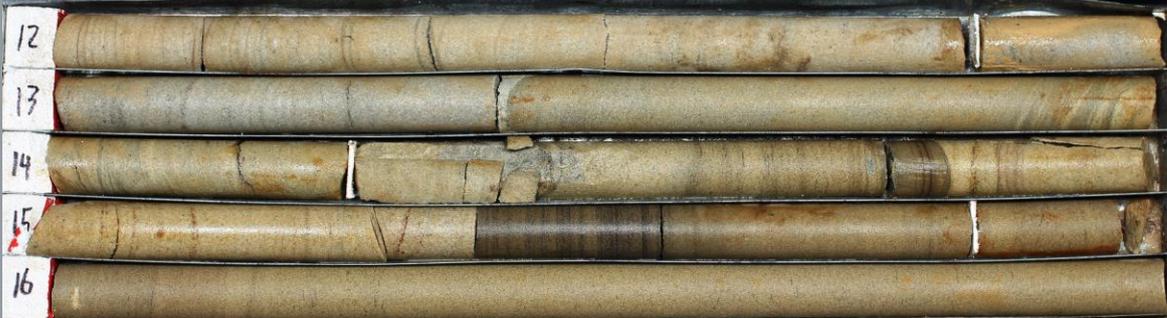
Project No: 200333-01
BH ID: BH1
Depth: 12.00 - 13.00m
Core Box No.: 3/4

12.00 - 17.00m

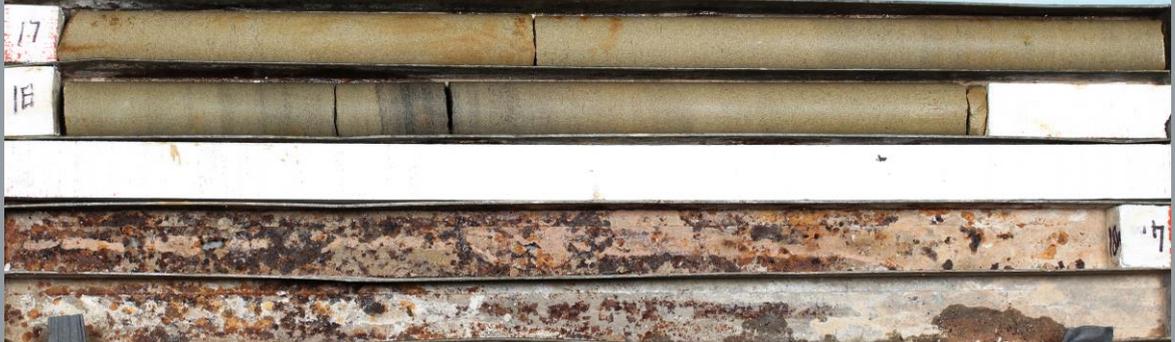
Project No: 200333-01
BH ID: BH1
Depth: 17.00 - 19.00m
Core Box No.: 4/4

17.00 - 19.00m

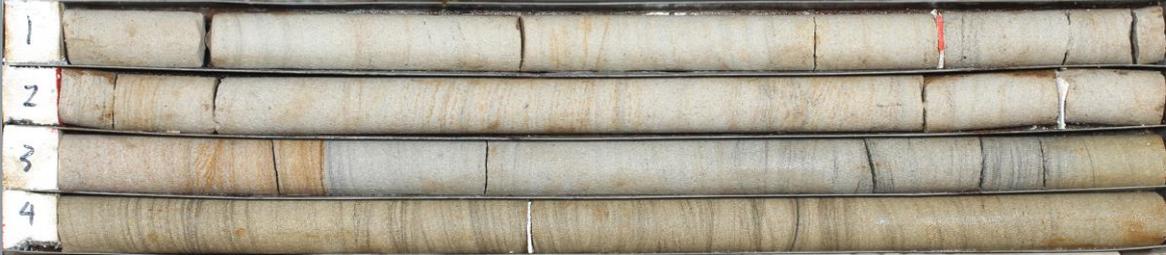
200333.01-Edgelyft-BH2 - Start=0.8

0.80 - 5.00m

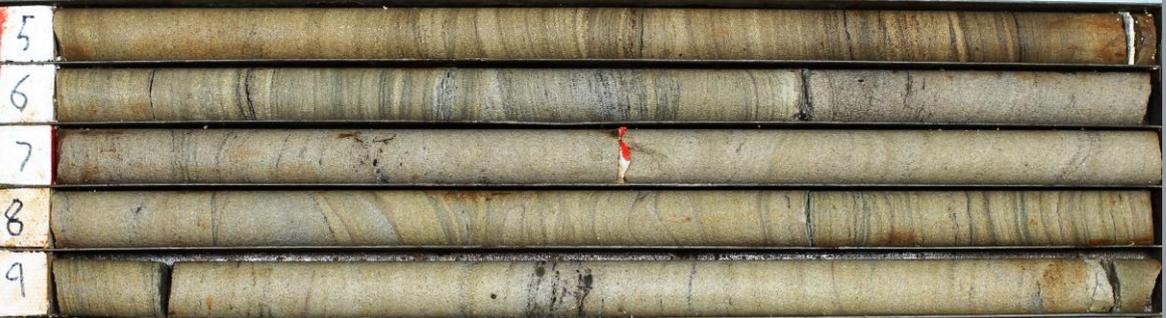
Project No: 200333.01
BH ID: BH 2
Depth: 5.00 - 10.00
Core Box No.: 2/3

5.00 - 10.00m

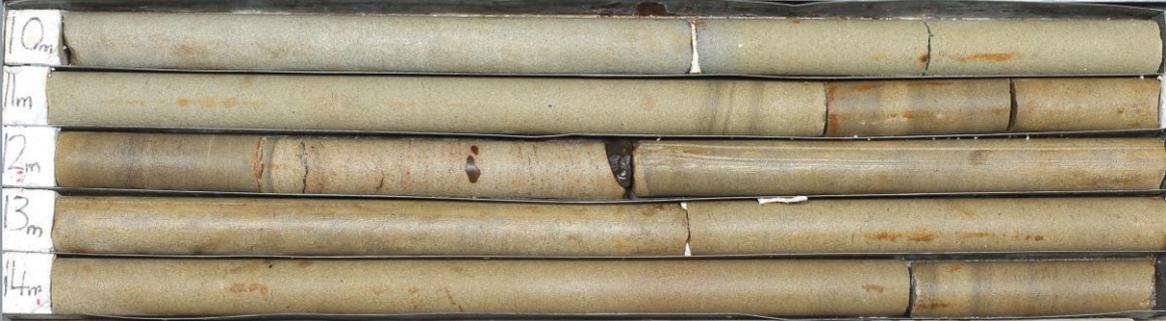
Core Box No.: 3/3

10.00 - 15.00m

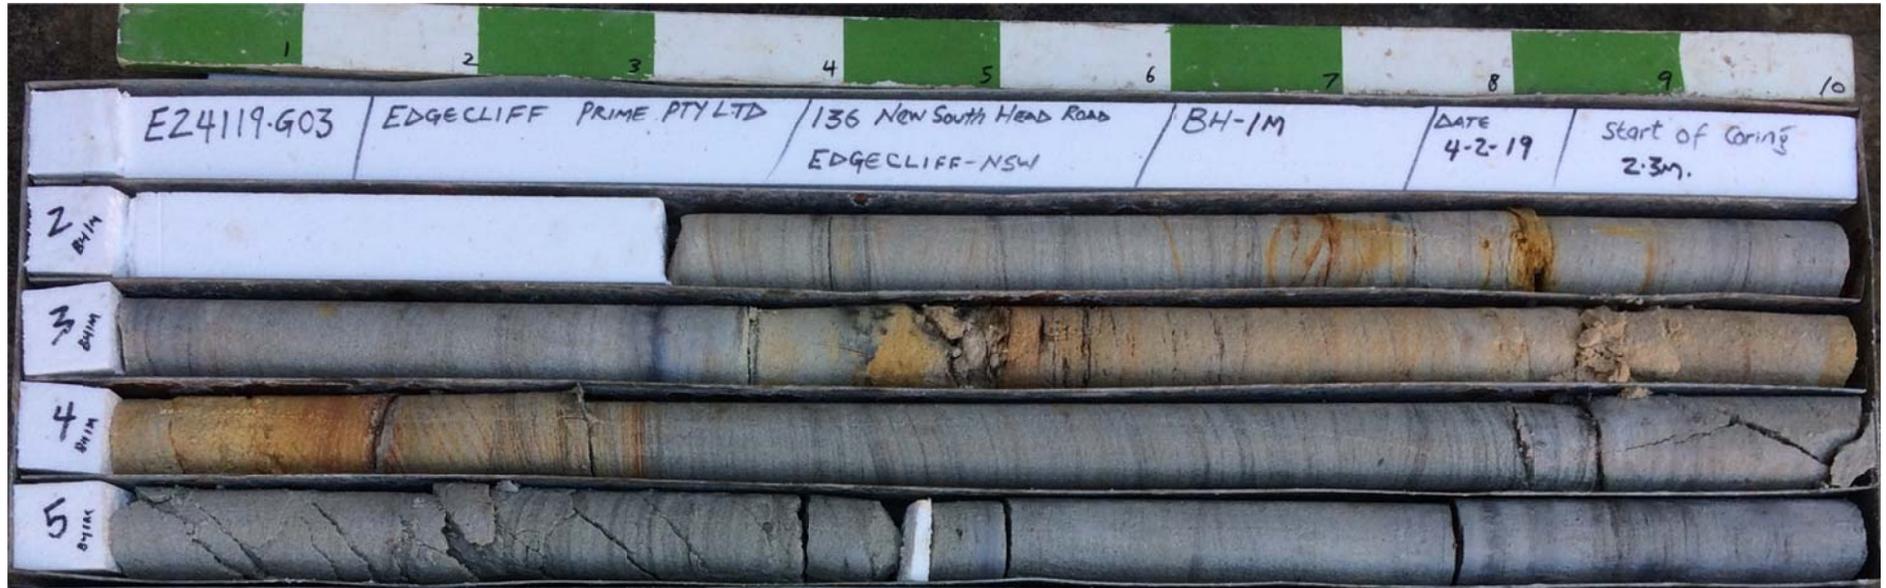
CORE PHOTOGRAPH OF BOREHOLE: 1M

Project	Proposed Residential Development	East	336810.4	Depth Range	2.3m to 12.65m BEGL	
Location	136 New South Head Road, Edgecliff NSW	North	6249929.7	Contractor	Geosense Drilling Engineers Pty Ltd	
Position	See Figure 2	Surface RL	≈ 32.7m	Drill Rig	Hanjin D&B 8D	
Job No.	E24119.G03	Inclination	-90°	Logged	AA	Date 04 / 02 / 2019
Client	Edgecliff Prime Pty Ltd	Box	1 of 3	Checked	NJ	Date 08 / 03 / 2019

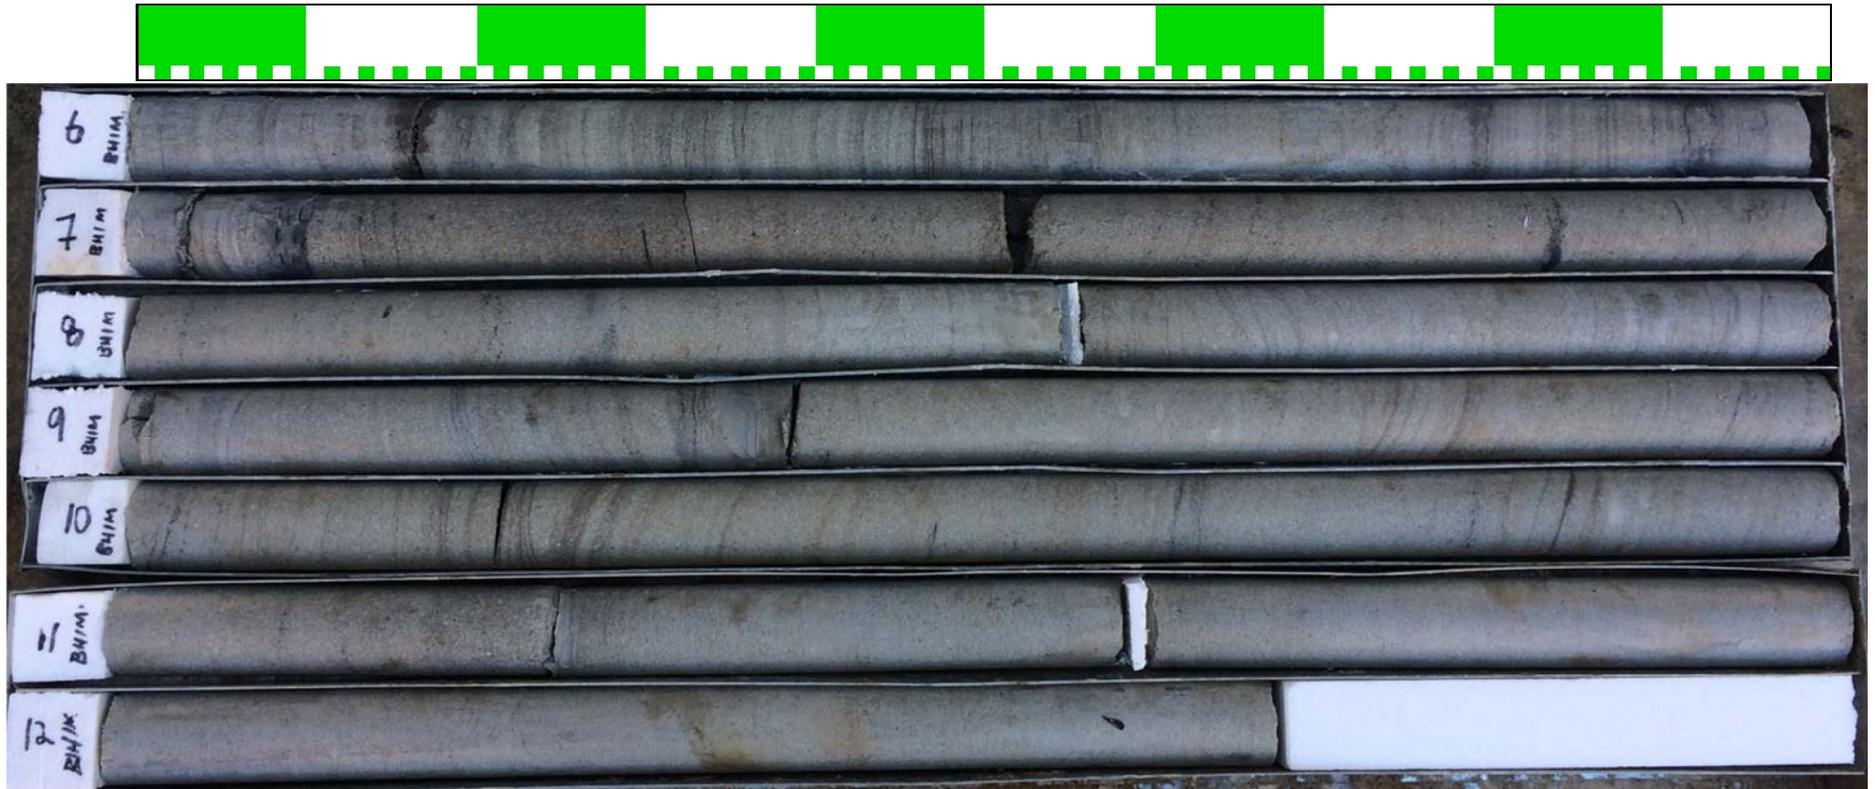
CORE PHOTOGRAPH OF BOREHOLE: 1M

Project	Proposed Residential Development	East	336810.4	Depth Range	2.3m to 2.65m BEGL
Location	136 New South Head Road, Edgecliff NSW	North	6249929.7	Contractor	Geosense Drilling Engineers Pty Ltd
Position	See Figure 2	Surface RL	≈ 32.7m	Drill Rig	Hanjin D&B 8D
Job No.	E24119.G03	Inclination	-90°	Logged	AA Date 04 / 02 / 2019
Client	Edgecliff Prime Pty Ltd	Box	2-3 of 3	Checked	NJ Date 08 / 03 / 2019

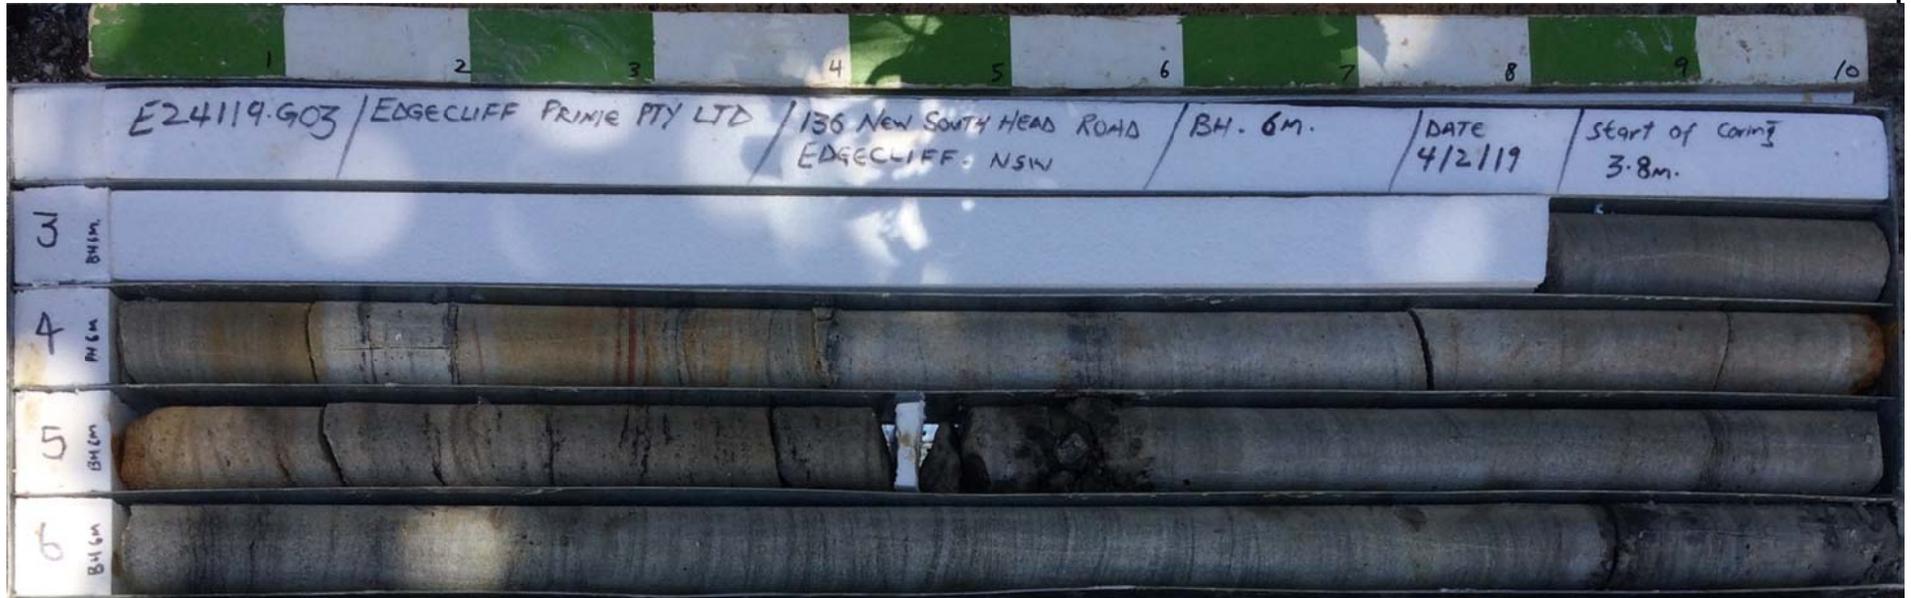
CORE PHOTOGRAPH OF BOREHOLE: 6M

Project	Proposed Residential Development	East	336793.4	Depth Range	3.8m to 13.0m BEGL	
Location	136 New South Head Road, Edgecliff NSW	North	6249936.9	Contractor	Geosense Drilling Engineers Pty Ltd	
Position	See Figure 2	Surface RL	≈ 32.8m	Drill Rig	Hanjin D&B 8D	
Job No.	E24119.G03	Inclination	-90°	Logged	AA	Date 04 / 02 / 2019
Client	Edgecliff Prime Pty Ltd	Box	1 of 3	Checked	NJ	Date 08 / 03 / 2019

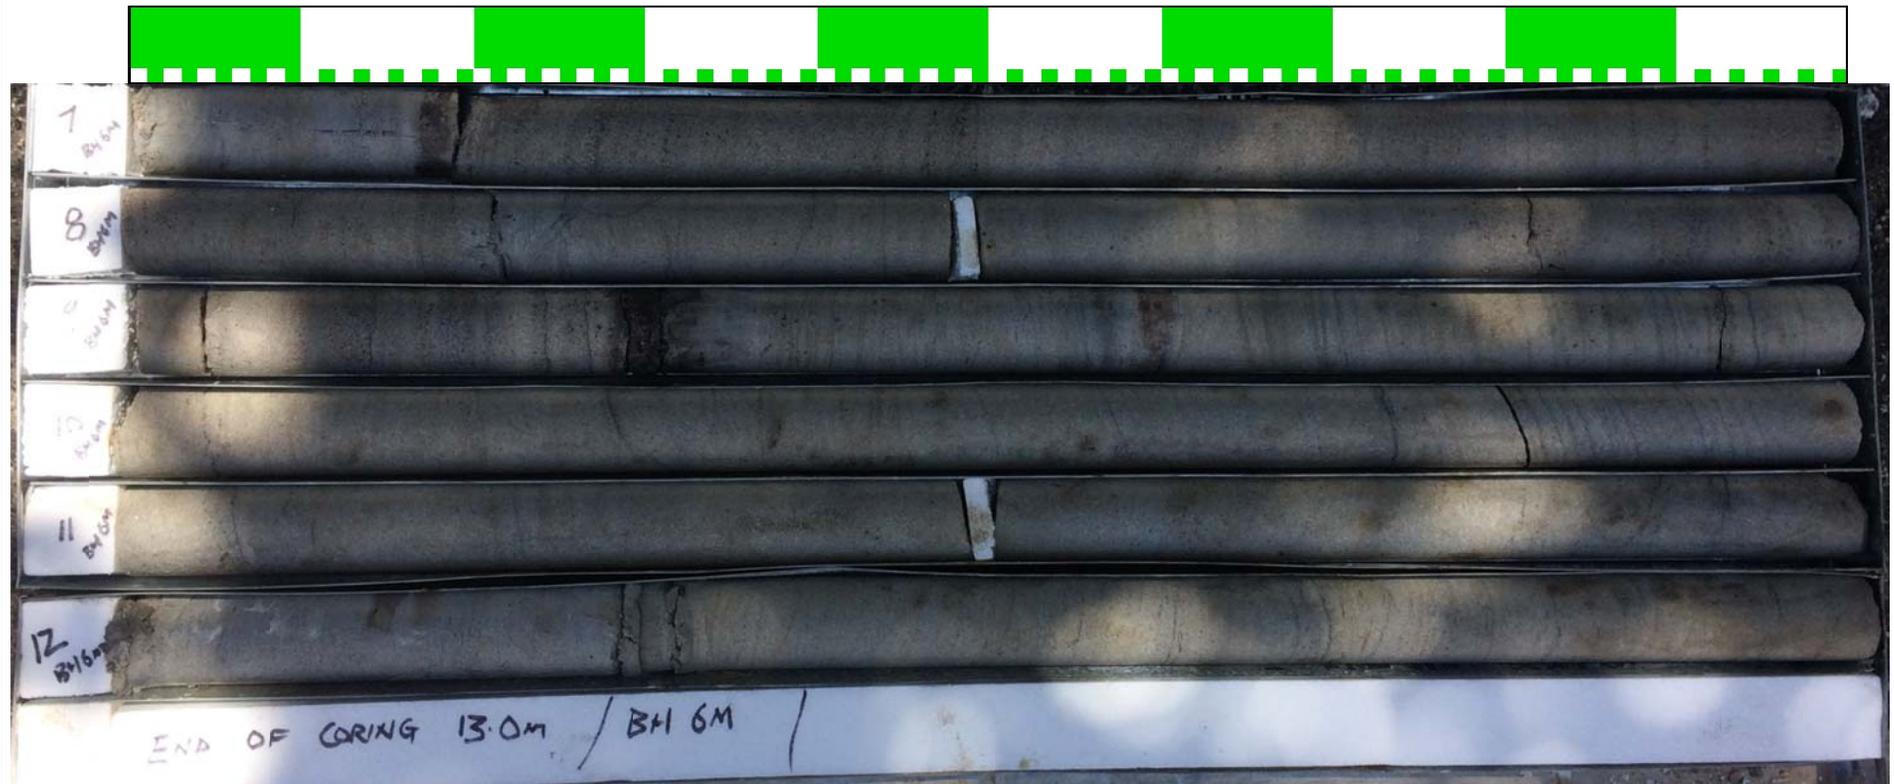
CORE PHOTOGRAPH OF BOREHOLE: 6M

Project	Proposed Residential Development	East	336793.4	Depth Range	3.8m to 13.0m BEGL	
Location	136 New South Head Road, Edgecliff NSW	North	6249936.9	Contractor	Geosense Drilling Engineers Pty Ltd	
Position	See Figure 2	Surface RL	≈ 32.8m	Drill Rig	Hanjin D&B 8D	
Job No.	E24119.G03	Inclination	-90°	Logged	AA	Date 04 / 02 / 2019
Client	Edgecliff Prime Pty Ltd	Box	2-3 of 3	Checked	NJ	Date 08 / 03 / 2019
